Bentley and Associates, LLC  
6683 Poplar Springs Rd  
Loudon, TN 37774  
865-986-2516  
Donnie Bentley TN Lic# 183

## *Home Inspection*

Happy Home Buyer  
101 Happy Home Lane  
Your town, TN 3333  
todays date

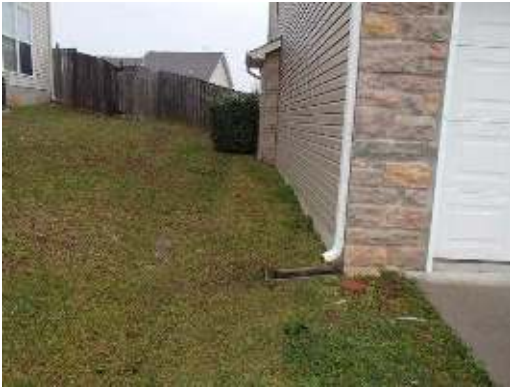
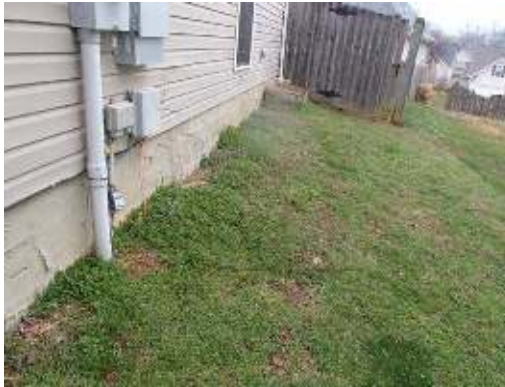
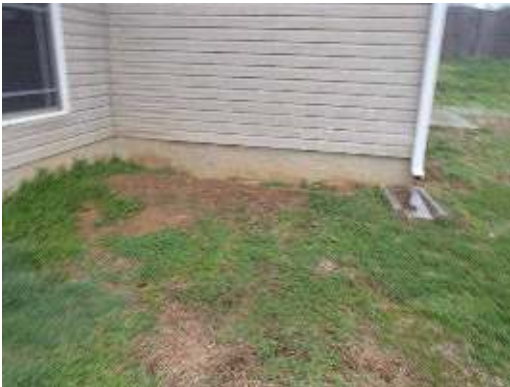
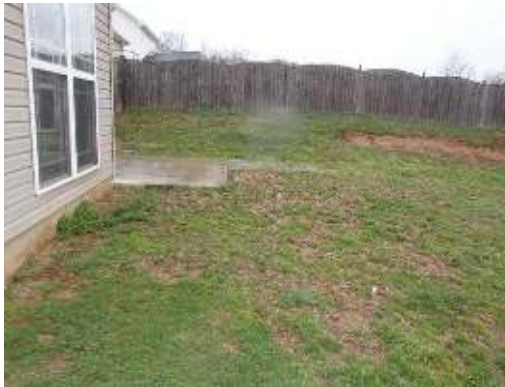
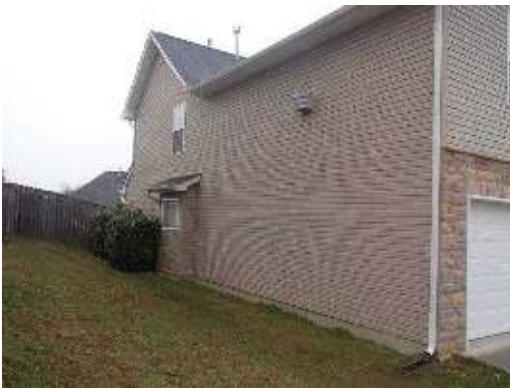
- 1. Acceptable Driveway: Concrete
- 2. Acceptable Walks: Concrete
- 3. Acceptable Porch: Concrete
- 4. Acceptable Patio: Concrete
- 5. Acceptable Grading: Minor slope
- 6. View of Grading
- 7. View View of Grade

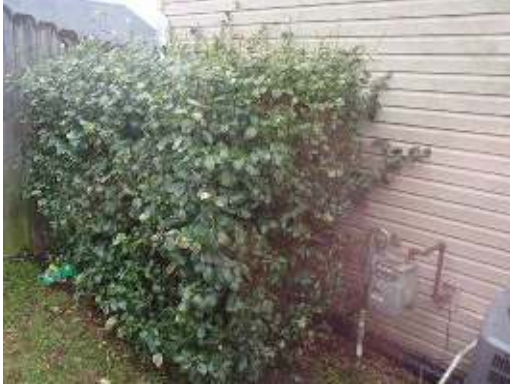
- 9. Acceptable Swale: Adequate slope and depth for drainage
- 10. Acceptable Vegetation: Shrubs - [Recommend trimming shrubs](#)

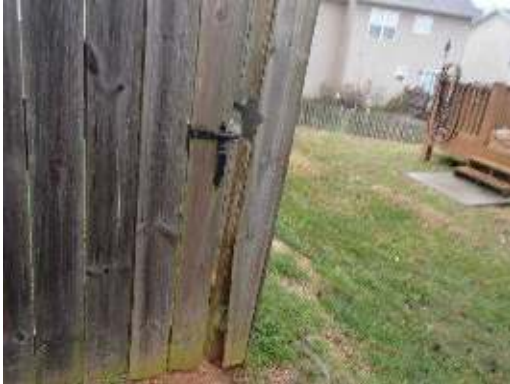
- 11. Marginal Fences: Privacy - [Damaged areas](#)

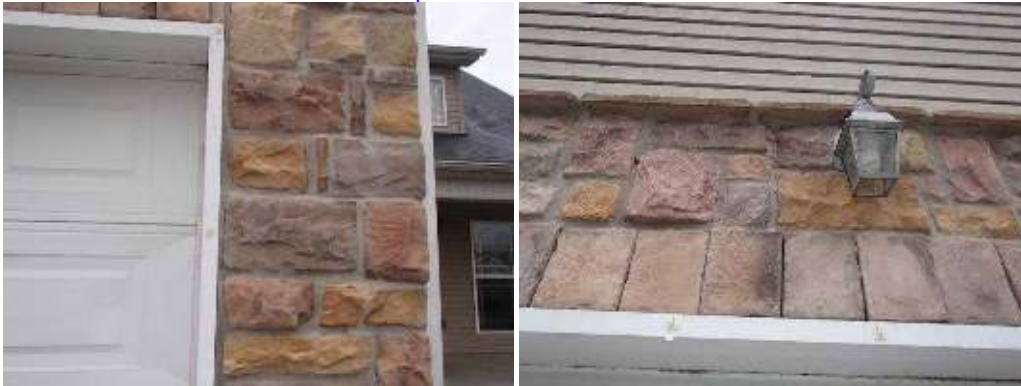
2. Acceptable Type: Faux Stone - Small cracks present

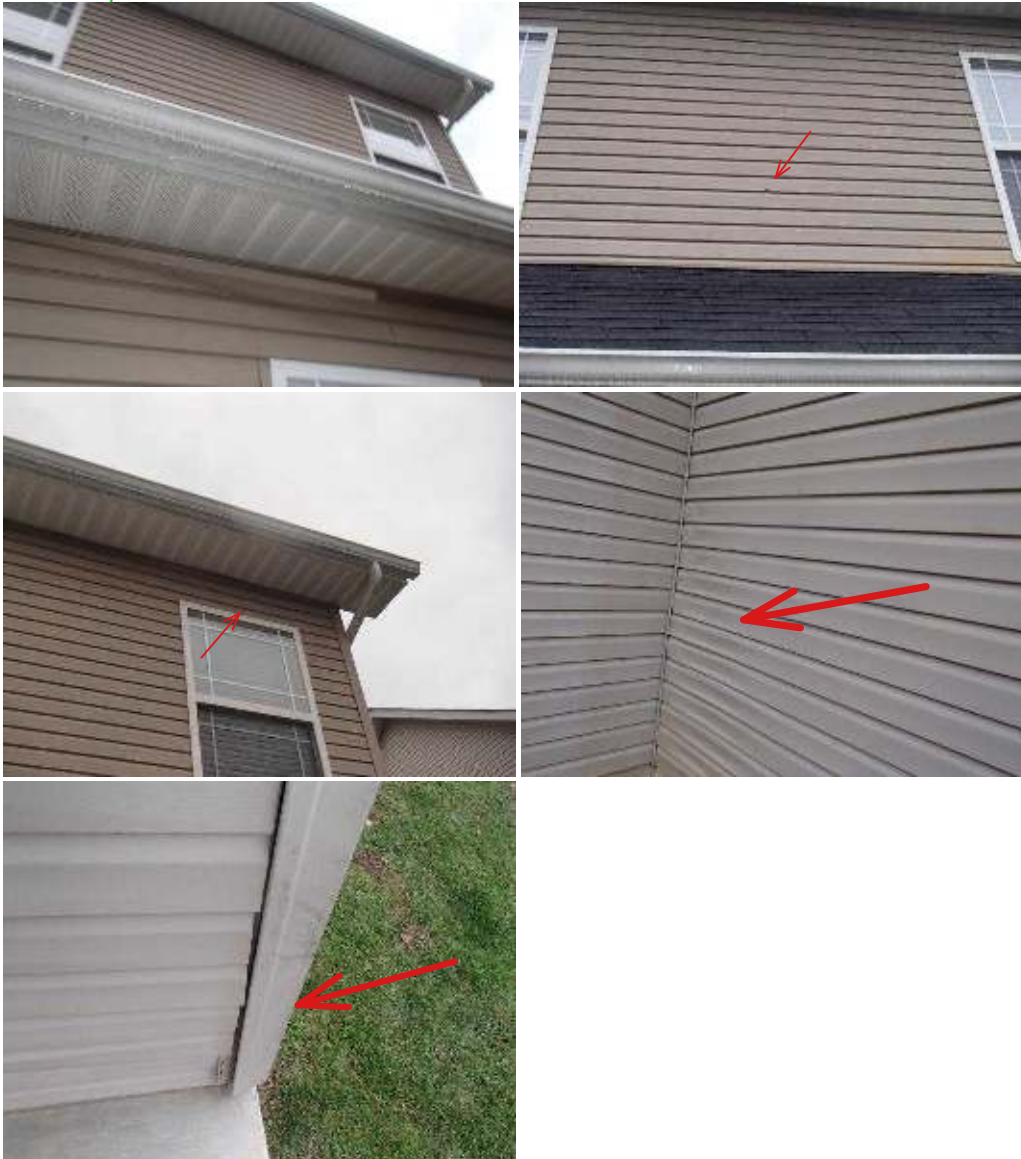
4. Marginal Type: Vinyl siding - Small holes and cracks in rear, Sagging from heat in rear corner, Loose section at front porch

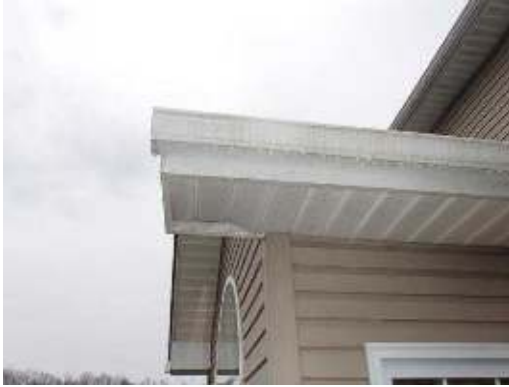
- 5. Not Present Trim: Wood, Aluminum and vinyl
- 6. Views of Exterior
- 7. Acceptable Fascia: Aluminum clad
- 8. Marginal Soffits: Vinyl - **Small section loose in rear**

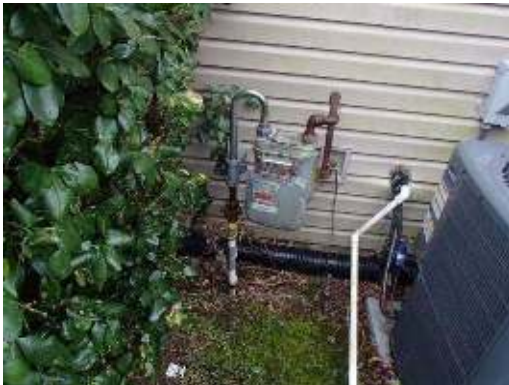
- 9. Acceptable Door Bell: Working properly
- 10. Acceptable Entry Door: Fiberglass clad
- 11. Acceptable Patio Door: Sliding
- 12. Acceptable Windows: Vinyl
- 13. Acceptable Exterior Lighting: Surface mount
- 14. Acceptable Exterior Electric Outlets: 110 VAC GFCI
- 15. Acceptable Hose Bibs: Rotary
- 16. Acceptable Gas Meter: Outside

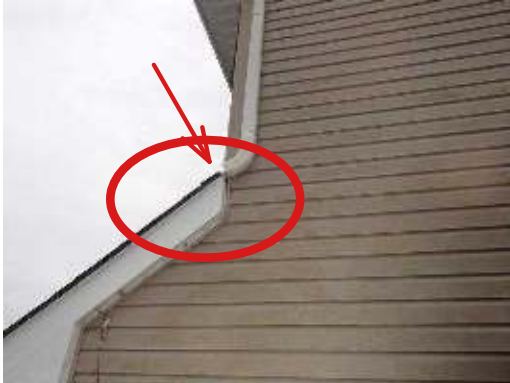
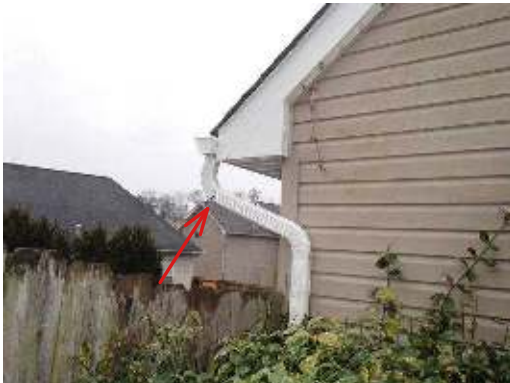
11. Defective Downspouts: Aluminum - **Rear left side downspout is turning water into opening above soffit recommend repair and have a contractor evaluate to see if there is water damage inside wall and repair downspout**

**Pulled loose in rear, Recommend repair**

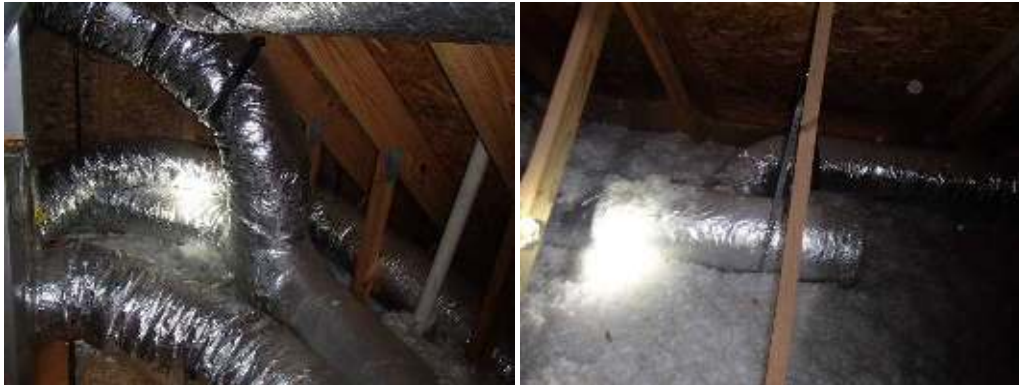
1. View of Attic

Main Attic

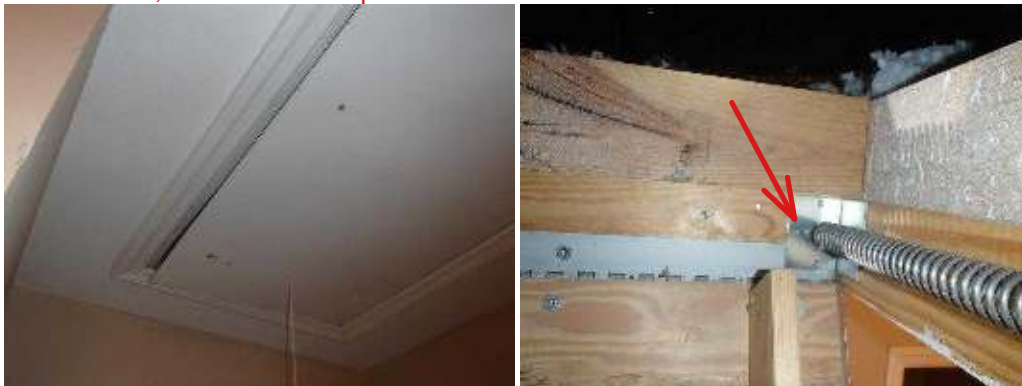
3. Defective Access Pull down - **Recommend adding nails to hole provided in the metal bracket at top Cover loose, recommend repair**

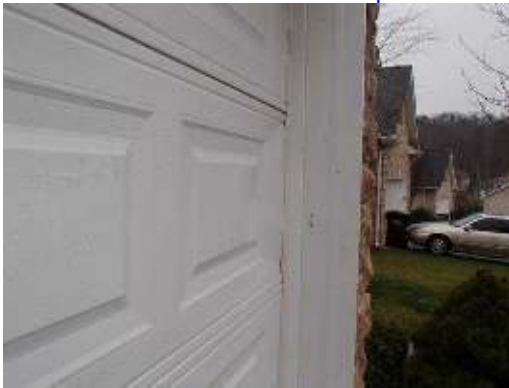
#### 3. Acceptable Garage Doors: Metal - **Dents present**

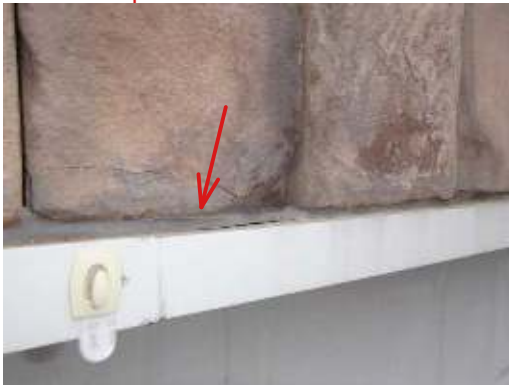
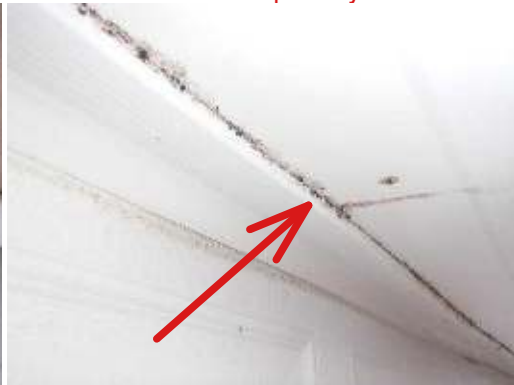
Garage door trim Aluminum clad - **Evidence of past water intrusion, Caulk added, Soft area on overhead piece of wood trim. Recommend evaluation and repair by a licensed contractor**

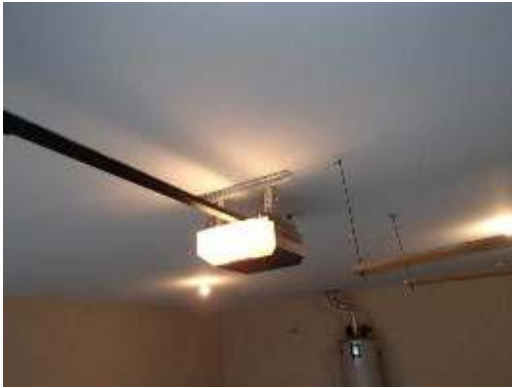
Door Operation: Mechanized  
Door Opener: Overhead Door

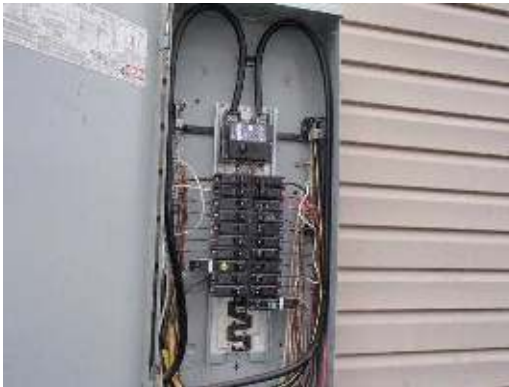
8. Acceptable Manufacturer: Cutler-Hammer

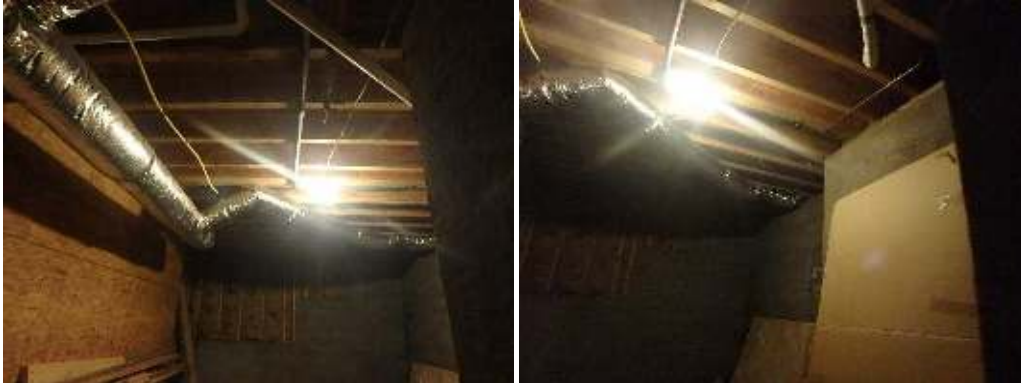
1. Acceptable Structure Type: Wood frame

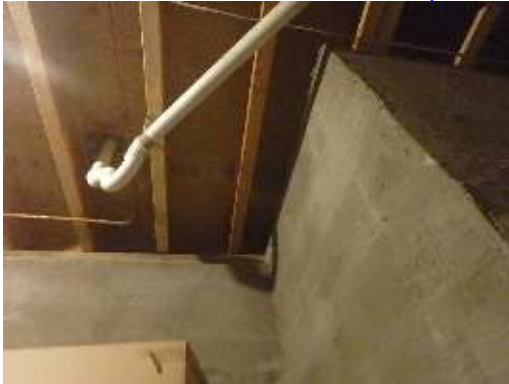
2. Acceptable Foundation: Block - [Small cracks present](#)

11. FYI Most hairline cracks in foundation walls, poured slabs and finished walls/ ceilings are normal settlement, but should be monitored for adverse changes.

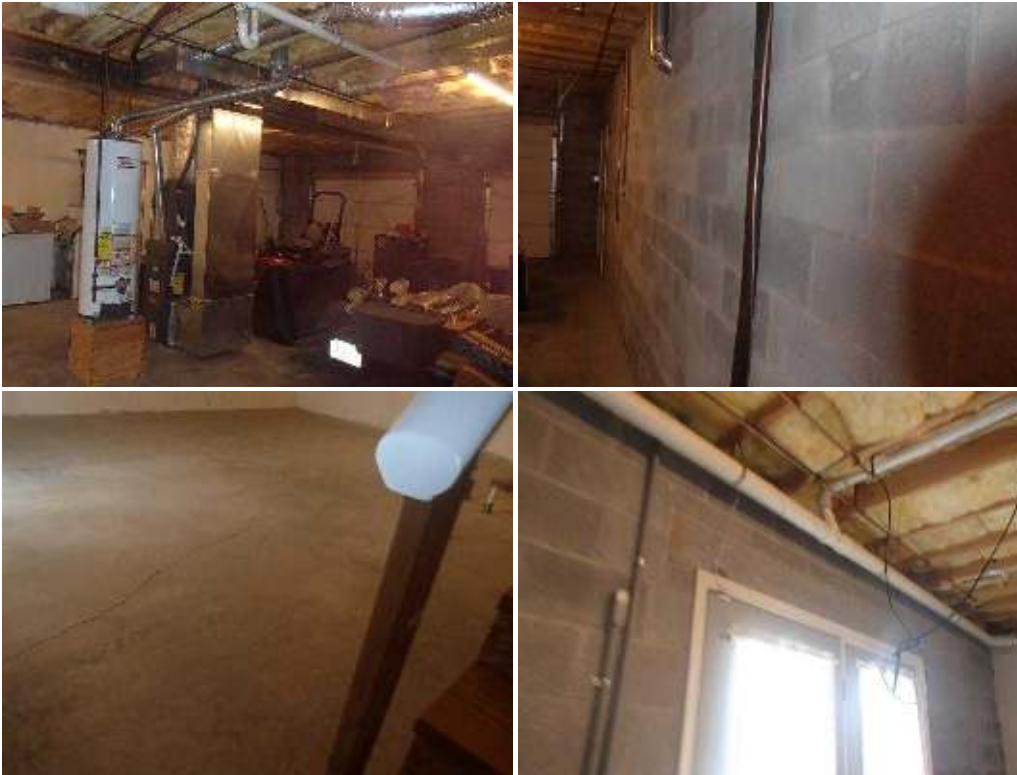
##### 1. Views of basement

- 2. Acceptable Ceiling: Exposed framing
- 3. Acceptable Walls: Block
- 4. Acceptable Floor: Concrete - **Cracks present**
- 5. Acceptable Electrical: 110 VAC GFCI
- 6. Acceptable Basement Stairs/ Railings: Present
- 7. Acceptable Insulation: Fiberglass
- 8. Acceptable Moisture Intrusion: Dry at the time of the inspection
- 9. Acceptable Smoke Detector: Present

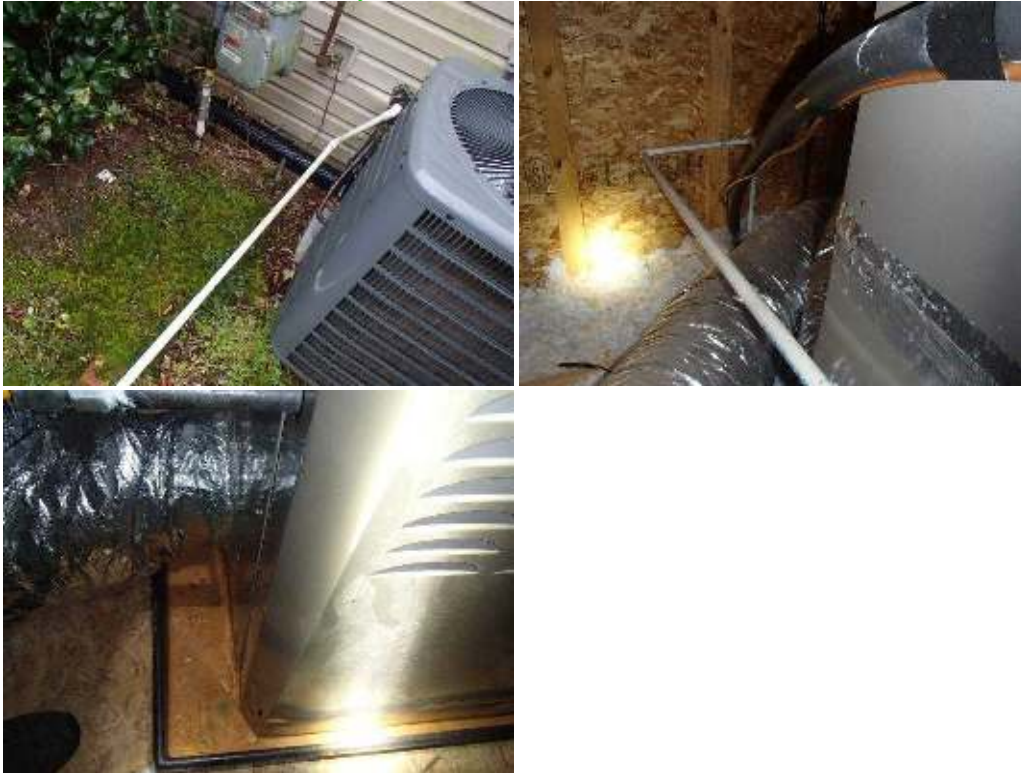
1. Acceptable A/C System Operation: Functional - **To avoid possible compressor damage due to outside temperature below 60 degrees, the unit was not tested.**
2. Marginal Condensate Removal: PVC - **There is evidence of past overflow in the drain pan inside the attic. There is no safety overflow switch present. Recommend installing a safety switch and having a HVAC contractor evaluate system**

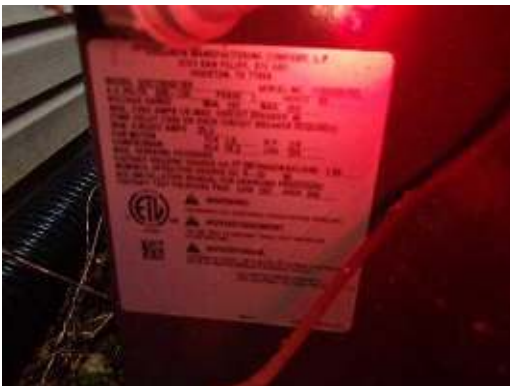
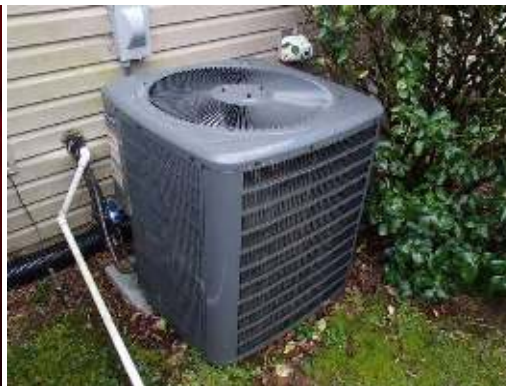
3. Acceptable Exterior Unit: Pad mounted
4. Manufacturer: Goodman

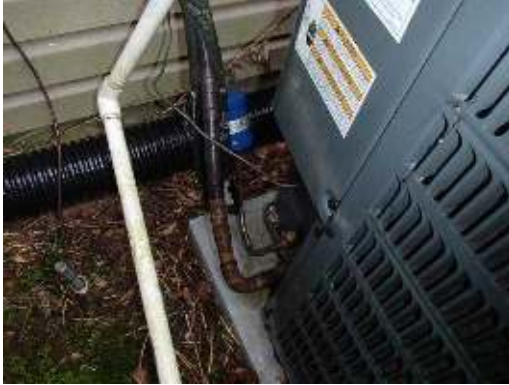
- 5. Area Served: Whole building Approximate Age: 4 Years
- 6. Fuel Type: Electric Temperature Differential: na
- 7. Type: Central A/ C Capacity: 3.5 Ton
- 8. Acceptable Visible Coil: Aluminum outside
- 9. Marginal Refrigerant Lines: Copper - **Missing insulation on refrigerant line, Recommend adding insulation to line**

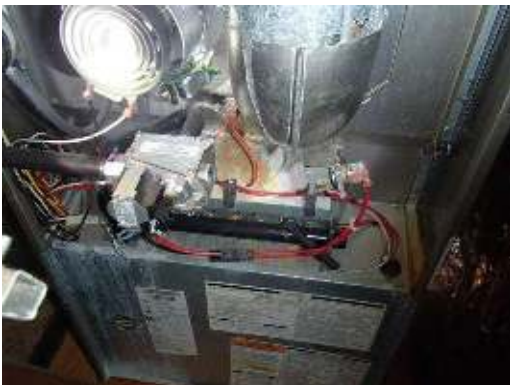
- 1. Acceptable Heating System Operation: Adequate
- 2. Manufacturer: Carrier

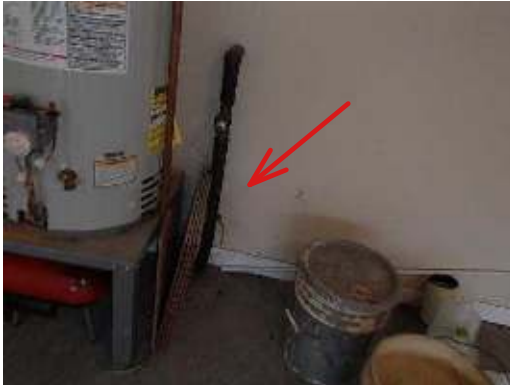
1. Acceptable Service Line: Copper

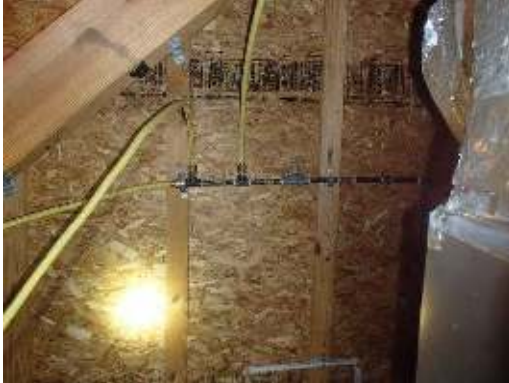
Gas Service Lines: (continued)

2. Acceptable Main Water Shutoff: Garage
3. Acceptable Water Lines: Copper
4. Acceptable Drain Pipes: PVC
5. Acceptable Vent Pipes: PVC
6. Defective Gas Service Lines: Cast iron, CSST - **Yellow Corrugated Stainless Steel Tubing (CSST) gas line present and does not appear bonded. Recommend a qualified licensed electrician evaluate and make any necessary repairs. For more information visit [www.csstsafety.com](http://www.csstsafety.com)**

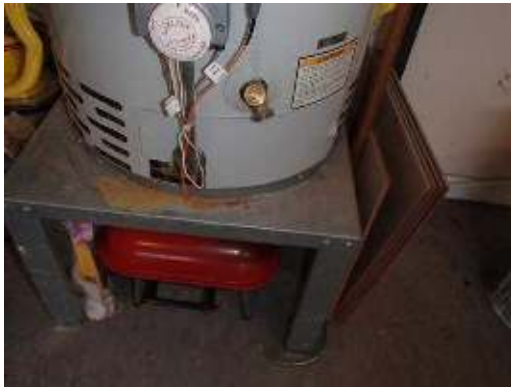
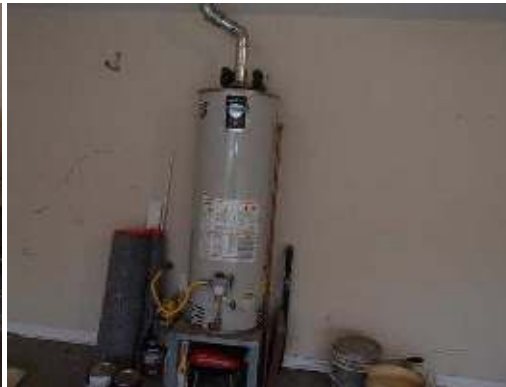
- 7. Acceptable Water Heater Operation: Adequate - [Stains noted](#)
- 8. Manufacturer: Bradford-White

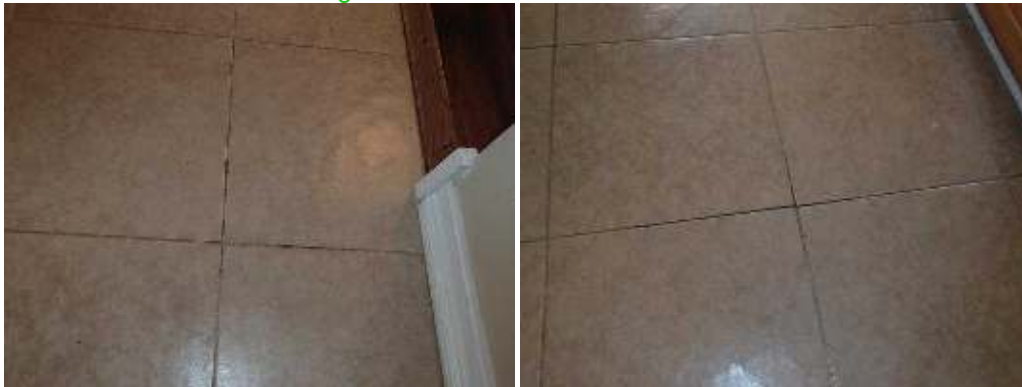
- 3. Acceptable Ceiling: Paint
- 4. Acceptable Walls: Paint
- 5. Marginal Floor: Tile - Cracks/ loose grout between tiles

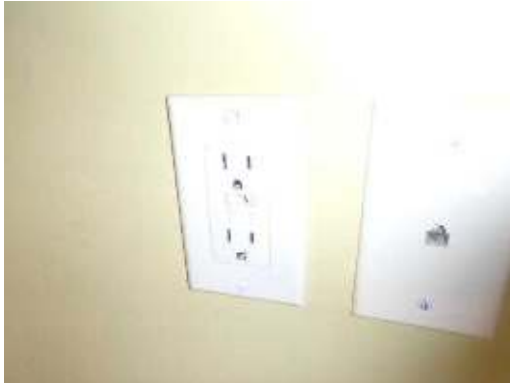
- 6. Acceptable Windows: Good condition
- 7. Defective Electrical: 110 VAC GFCI - GFCI Outlet on counter is cracked, Recommend replacement

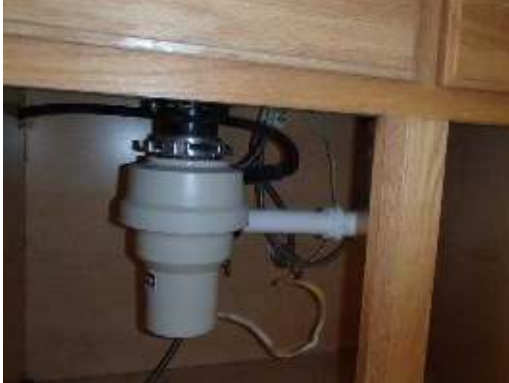
9. Acceptable Plumbing/ Fixtures: Adequate

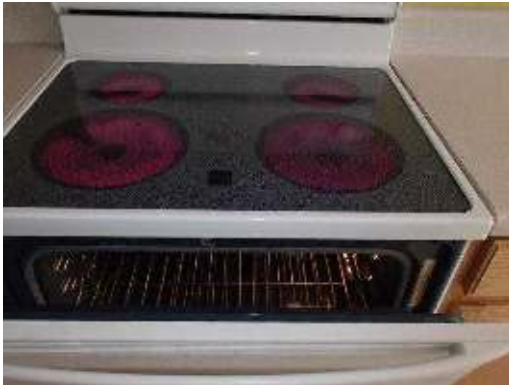
10. Acceptable Sink: Good condition  
11. Acceptable Disposal: In-Sinkerator  
12. Acceptable Dishwasher: Maytag  
13. Acceptable Cooking Appliances: Whirlpool

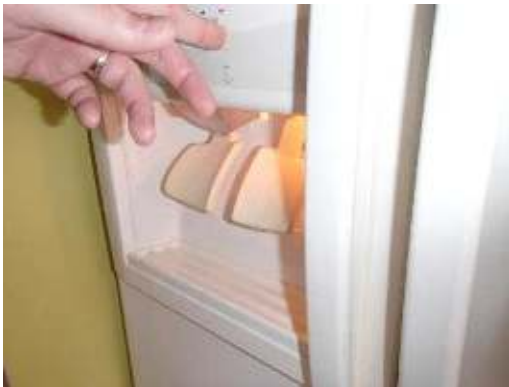
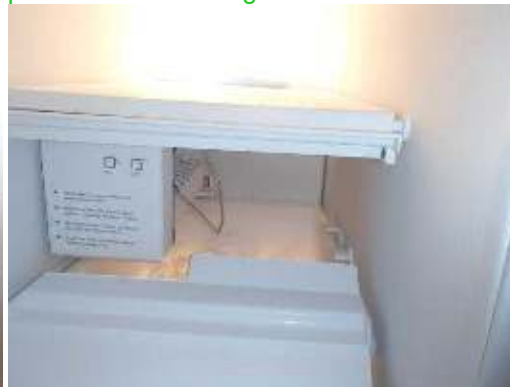
14. Acceptable Ventilator: Present  
15. Marginal Refrigerator: Whirlpool - Door water dispenser not working

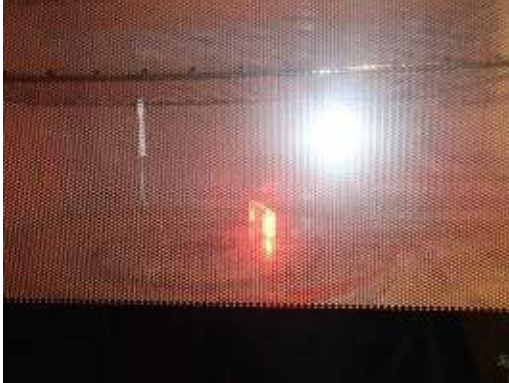
16. Acceptable Microwave: General Electric

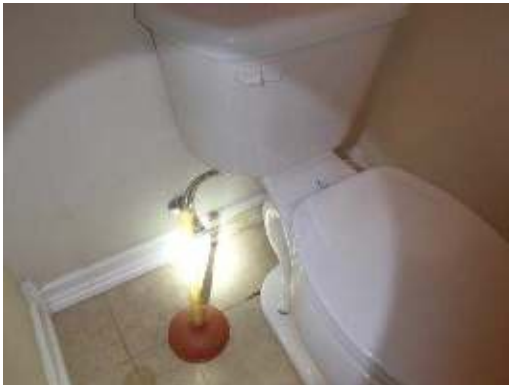
Toilets: Adequate - The toilet is loose at the floor and may require replacement of the wax seal

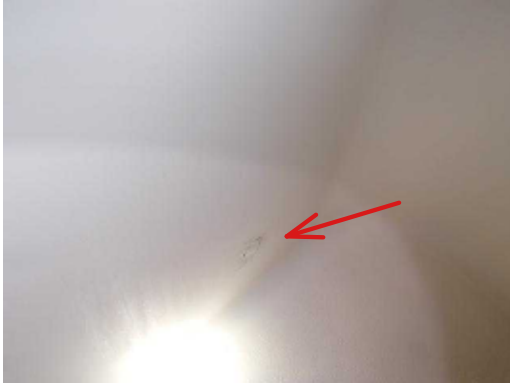
25. Defective Shower/ Surround: Plastic/ fiberglass - **Hole with improper repair, Recommend repairs be made by a professional**  
**Faucet dripping, Recommend repair**

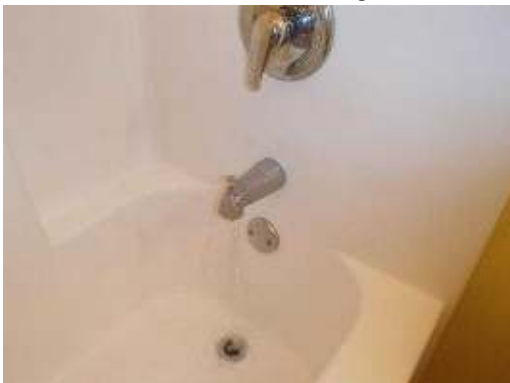
27. Acceptable Ceiling: Paint  
28. Acceptable Walls: Paint  
29. Acceptable Floor: Vinyl floor covering  
30. Acceptable Doors: Working Properly  
31. Acceptable Electrical: 110 VAC GFCI  
32. Acceptable HVAC Source: Present  
33. Acceptable Ventilation: Present  
34. Acceptable Faucets/ Traps: Adequate  
35. Acceptable Sink/ Basin: Single bowl  
36. Acceptable Counter/ Cabinet: Adequate  
37. Defective Tub/ Surround: Plastic/ Fiberglass - **Diverter stuck on shower control**

10. Upstairs Bathroom Tub/ Surround: Plastic/ Fiberglass - **Diverter stuck on shower control**

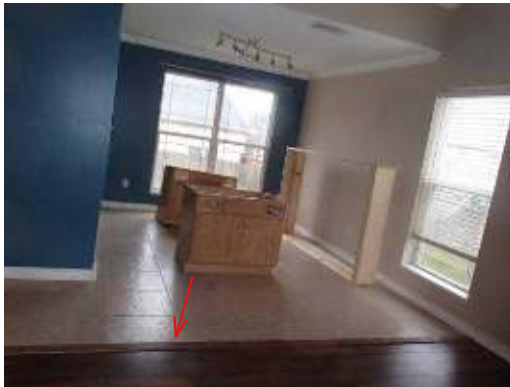
- 2. Acceptable Ceiling: Paint
- 3. Acceptable Walls: Paint
- 4. Marginal Floor: Laminant - **Loose trim**

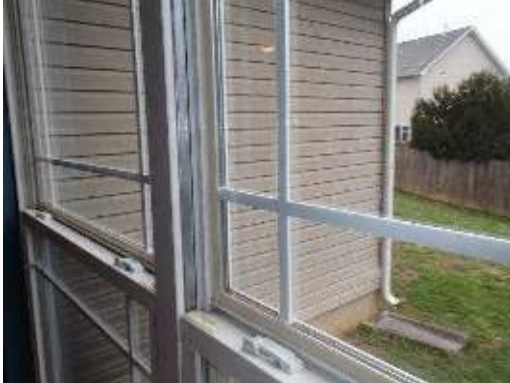
13. Marginal Windows: Good condition - **Right rear window not working properly**

11. Dining Room Living Space Windows: Good condition - Right rear window not working properly

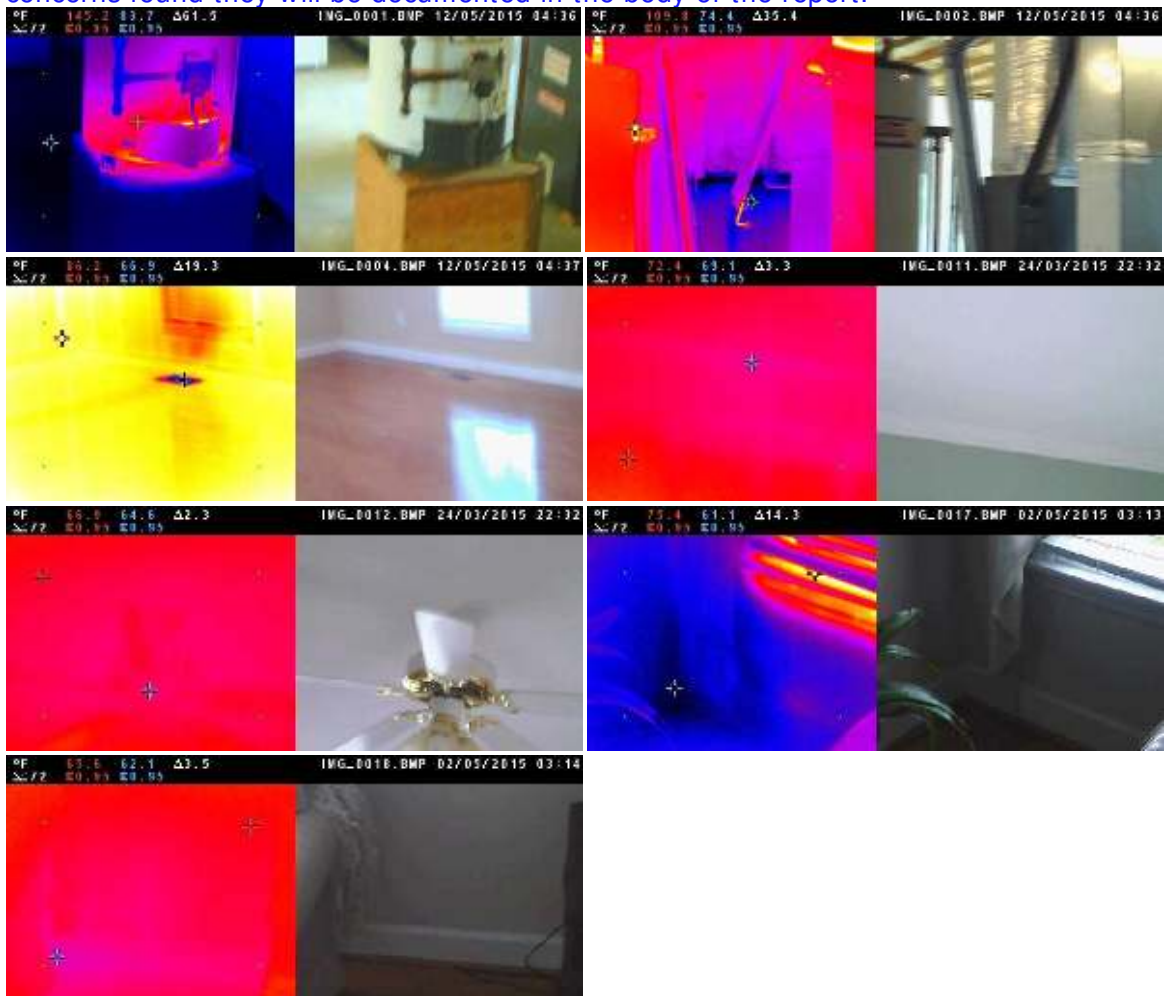
1. Acceptable Building Scan No concerns were noted in scan - This is for your information and is not a complete energy scan of the building. This is some pictures we took during the inspection to provided a better home inspection. Infrared cameras can not see through walls but are very effective at documenting consistent temperature which is congruent with dry surfaces. If there were and concerns found they will be documented in the body of the report.

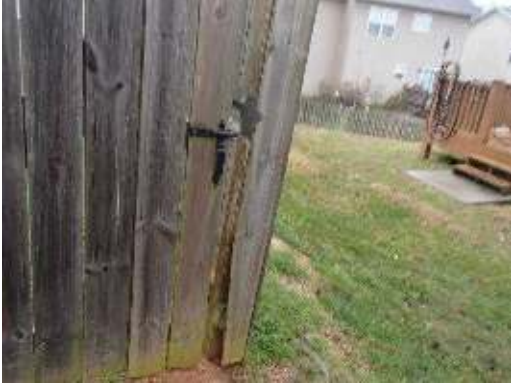
#### 1. Fences: Privacy - Damaged areas

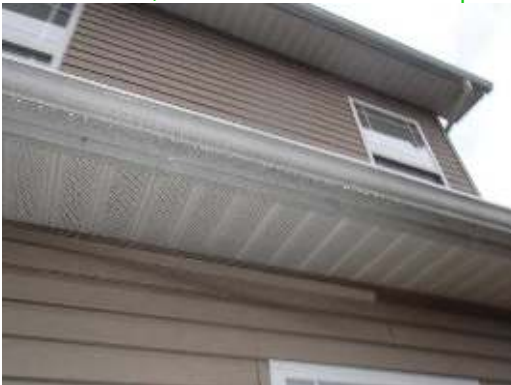
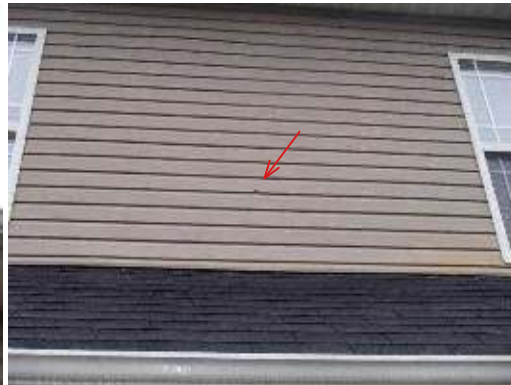
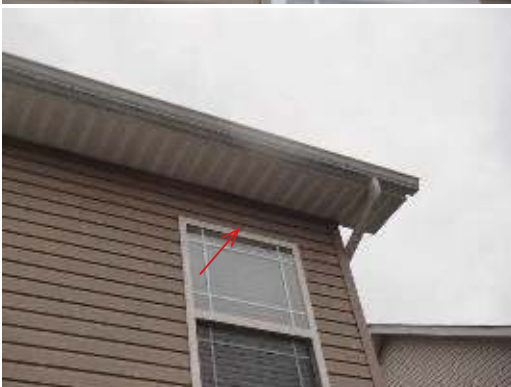
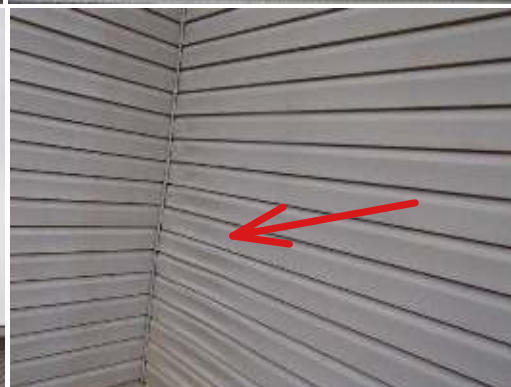
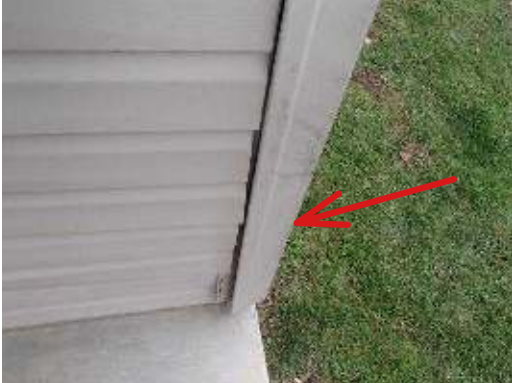
#### 2. Main, Sides and rear Exterior Surface Type: Vinyl siding - Small holes and cracks in rear, Sagging from heat in rear corner, Loose section at front porch

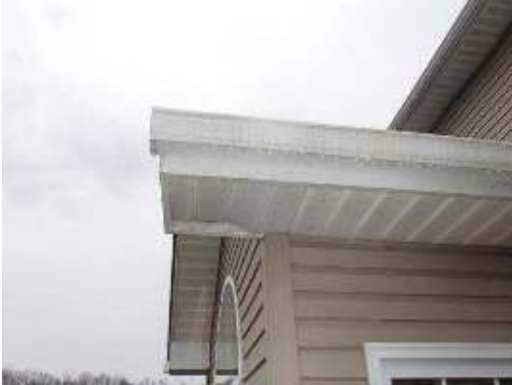
3. Soffits: Vinyl - Small section loose in rear

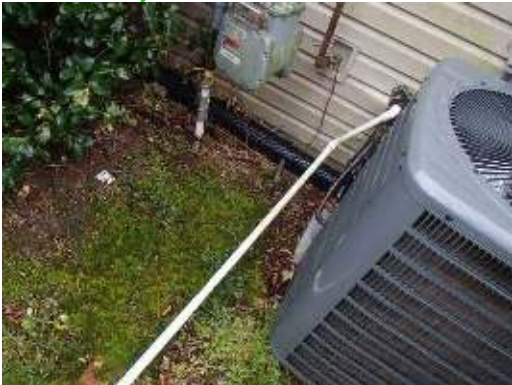
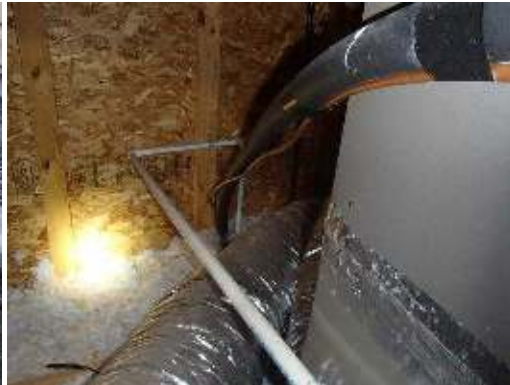
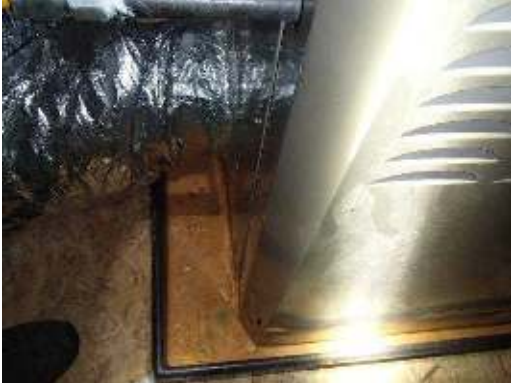
4. Main AC System Condensate Removal: PVC - There is evidence of past overflow in the drain pan inside the attic. There is no safety overflow switch present. Recommend installing a safety switch and having a HVAC contractor evaluate system

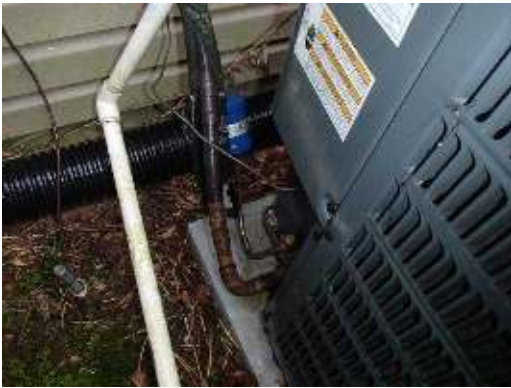
5. Main AC System Refrigerant Lines: Copper - **Missing insulation on refrigerant line, Recommend adding insulation to line**

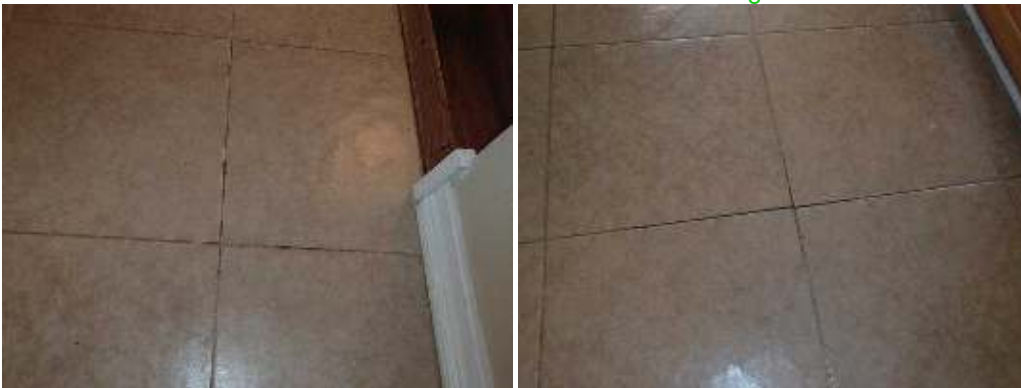
6. Kitchen and dining area Kitchen Floor: Tile - **Cracks/ loose grout between tiles**

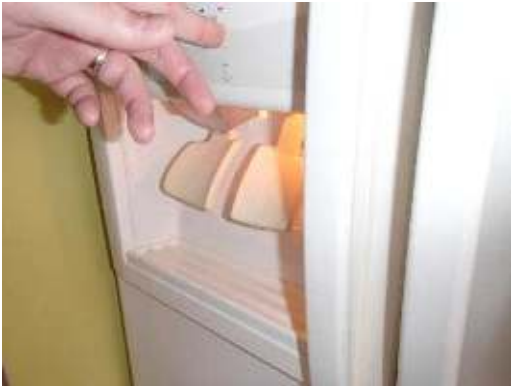
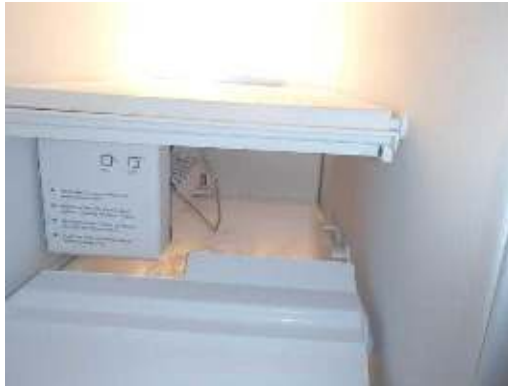
7. Kitchen and dining area Kitchen Refrigerator: Whirlpool - **Door water dispenser not working**

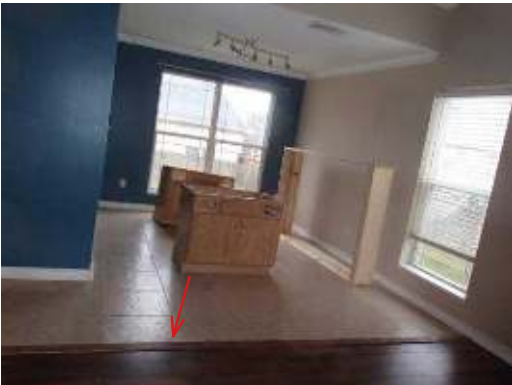
10. Living Room Living Space Floor: Laminant - Loose trim

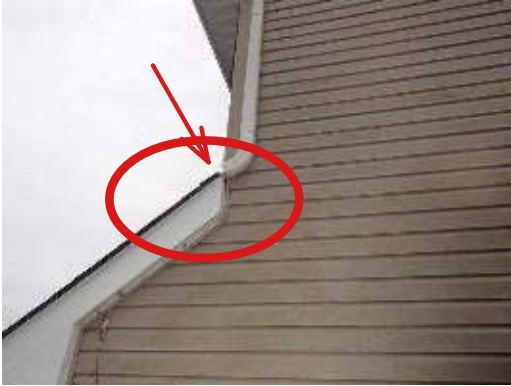
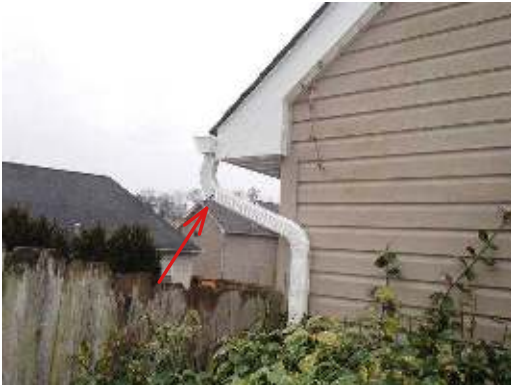
1. Downspouts: Aluminum - Rear left side downspout is turning water into opening above soffit recommend repair and have a contractor evaluate to see if there is water damage inside wall and repair downspout Pulled loose in rear, Recommend repair

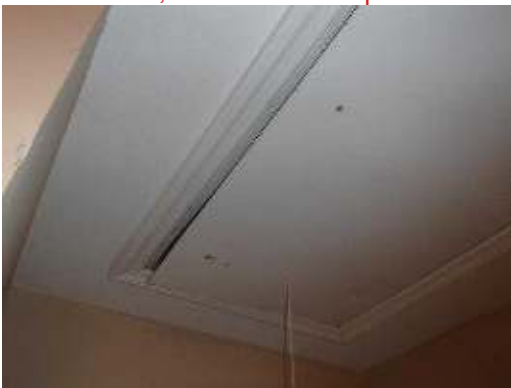
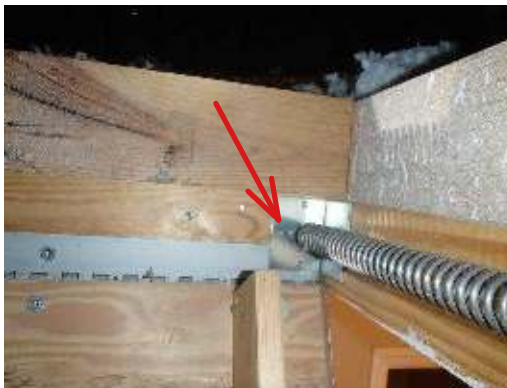
2. Main Attic Access Pull down - Recommend adding nails to hole provided in the metal bracket at top Cover loose, recommend repair

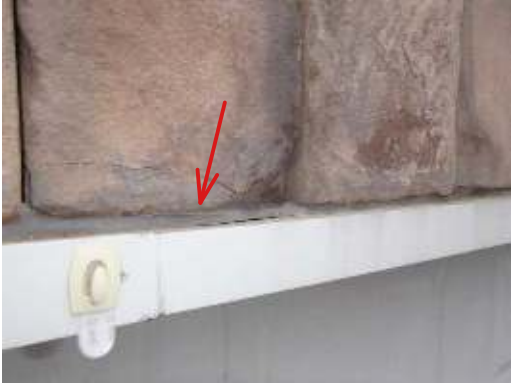
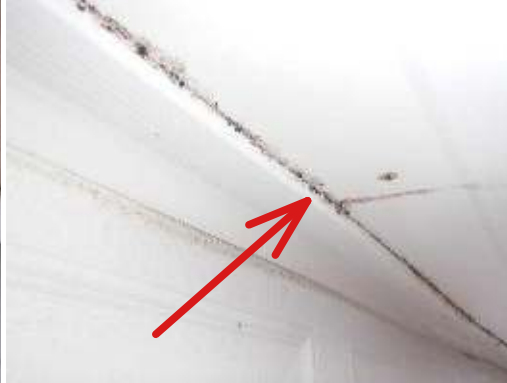
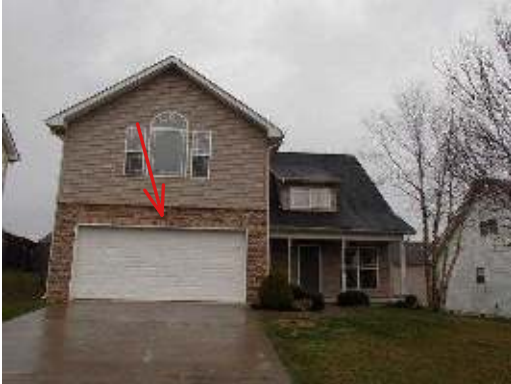
Garage door trim (continued)

3. Attached Garage Garage door trim Aluminum clad - Evidence of past water intrusion, Caulk added, Soft area on overhead piece of wood trim. Recommend evaluation and repair by a licensed contractor

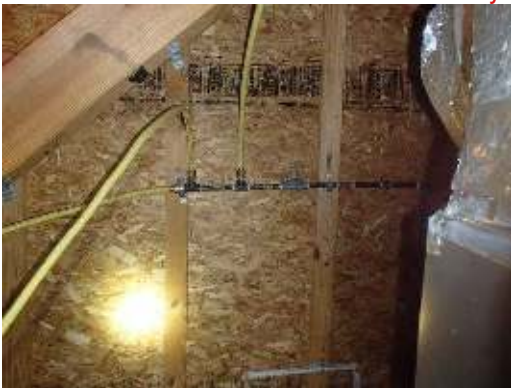
4. Gas Service Lines: Cast iron, CSST - Yellow Corrugated Stainless Steel Tubing (CSST) gas line present and does not appear bonded. Recommend a qualified licensed electrician evaluate and make any necessary repairs. For more information visit [www.csstsafety.com](http://www.csstsafety.com)

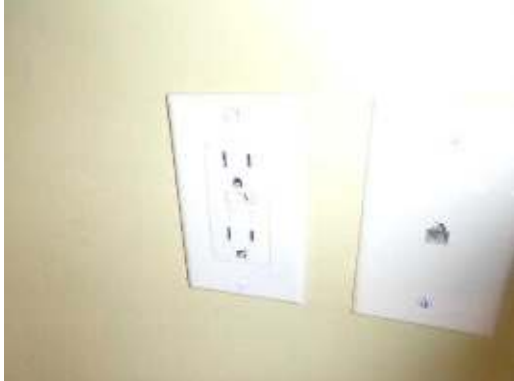
5. Kitchen and dining area Kitchen Electrical: 110 VAC GFCI - **GFCI Outlet on counter is cracked, Recommend replacement**

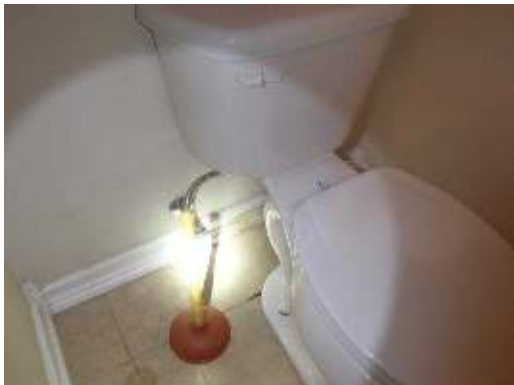
6. 1st floor hall, 1/2 Bath Bathroom Toilets: Adequate - **The toilet is loose at the floor and may require replacement of the wax seal**

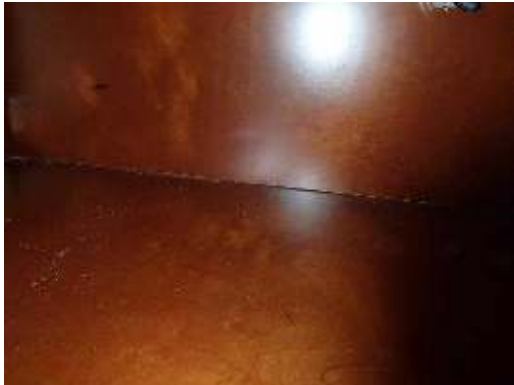
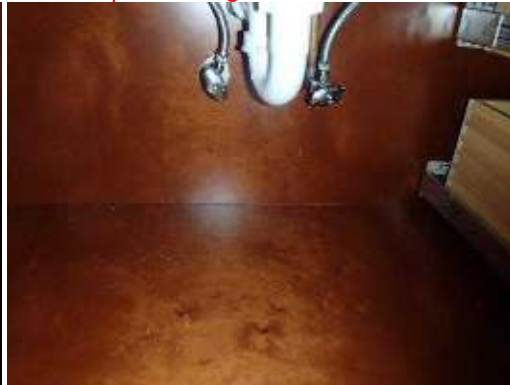
7. Master Bathroom Faucets/ Traps: Adequate - **Traps leaking under both sinks**

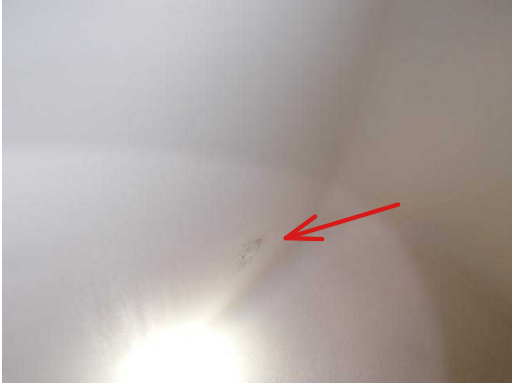
9. Master Bathroom Shower/ Surround: Plastic/ fiberglass - **Hole with improper repair, Recommend repairs be made by a professional**  
**Faucet dripping, Recommend repair**
